Transformer Fire Isolated

Tightly packed Las Vegas Strip substation experiences a dramatic transformer fire, but high-tech firewalls protect nearby equipment.

By **Gordon Smith**, *NV Energy*

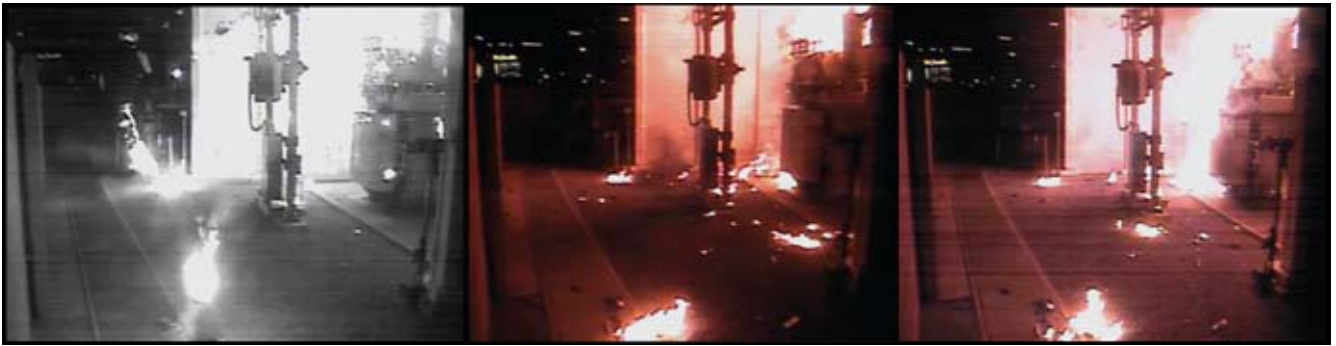
These are frames from the security camera in the Sinatra Station. Note how the first frame seems to be black and white, until the developing transformer fire starts to provide some more colorful lighting.

At 12:15 a.m. on Sunday, May 15, 2011, an explosion and fire occurred at the Sinatra substation. As a result of the fire, numerous pieces of the bushings flew off the large 230/138-

kV autotransformer and became embedded in the firewalls. Fueled by the transformer's mineral oil, the fire quickly engulfed the entire transformer. Observers from nearby hotels and the interstate saw flames shoot into the dark sky, which some estimated to be as high as 80 ft (24 m). The incident made national news.

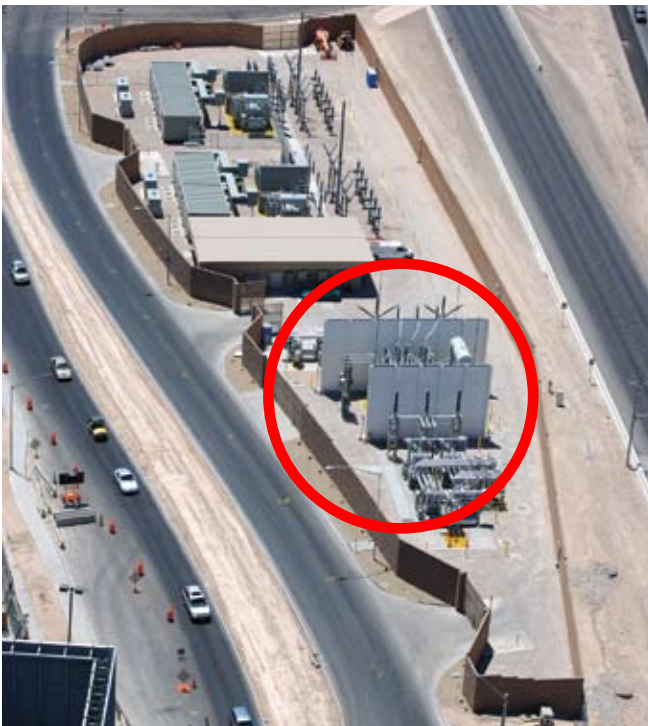
Aerial view of the entire Sinatra substation showing the location of the fire.

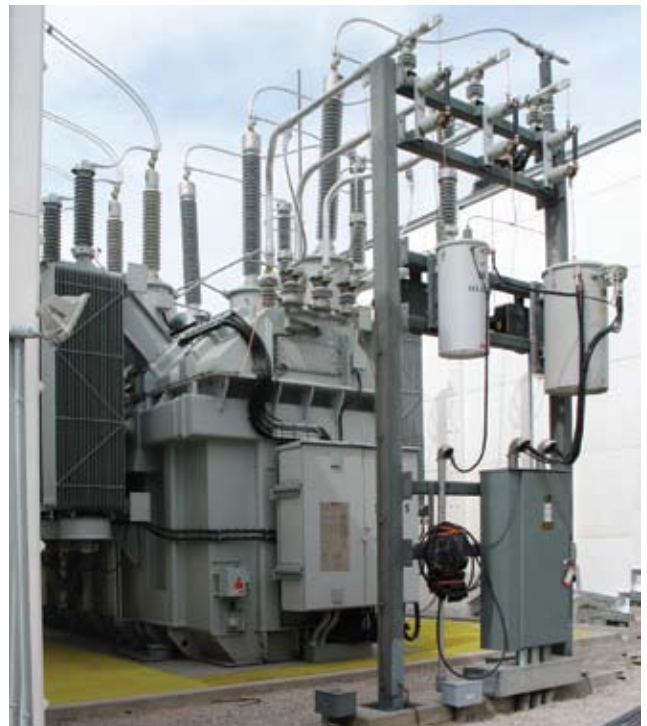
The 230/138-kV autotransformer tucked between the two ceramic panel firewalls before the fire.

sary safety protections and competitive pricing with more traditional concrete firewalls. The substation designers specified two Intelli-Firewalls from Composite Support & Solutions Inc. These two walls — which measured 41 ft wide by 28 ft tall (12.5 m by 8.5 m) and 58 ft wide by 28 ft tall (17.7 m by 8.5 m) — were designed to withstand a hydrocarbon fire for up to four hours.

The modular panels were relatively lightweight at 320 lb (145 kg) each, and easy to maneuver and install. Each hollow panel used a heat-resistant surface similar to what has been used on NASA space shuttle tiles. In the case of the tight-spaced Sinatra substation, the panels also offered the flexibility of easy removal and reassembly, should NV Energy find it necessary to replace or maintain the large 230/138-kv autotransformer. In fact, a single wall can be assembled or disassembled in less

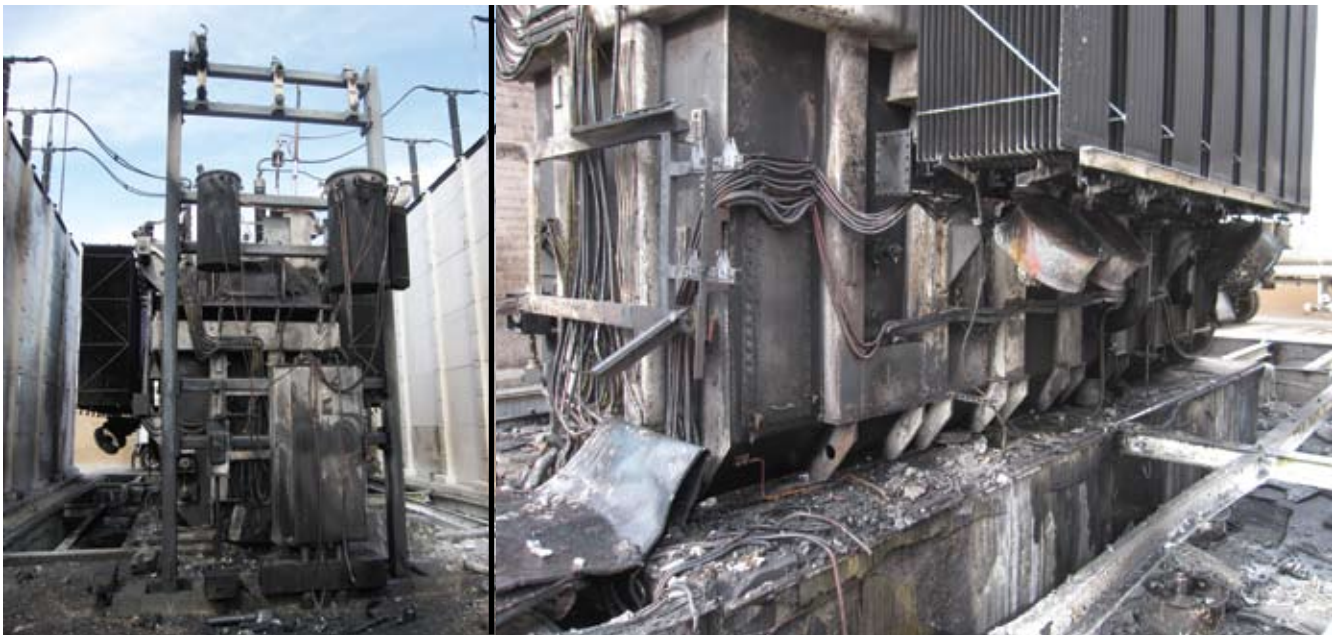
Front and side views of the burned unit with the tertiary structure beside it, although all the equipment on this structure was destroyed, NV Energy was able to repaint and put the steel structure back in service.

In spite of the initial explosion and sustained oil-fed fire, both firewalls that bookended the autotransformer were remarkably intact. More importantly, the GIS equipment located behind the firewalls was protected from the heat and explosion. It was not damaged and remained available for service. The autotransformer was a total loss, naturally.

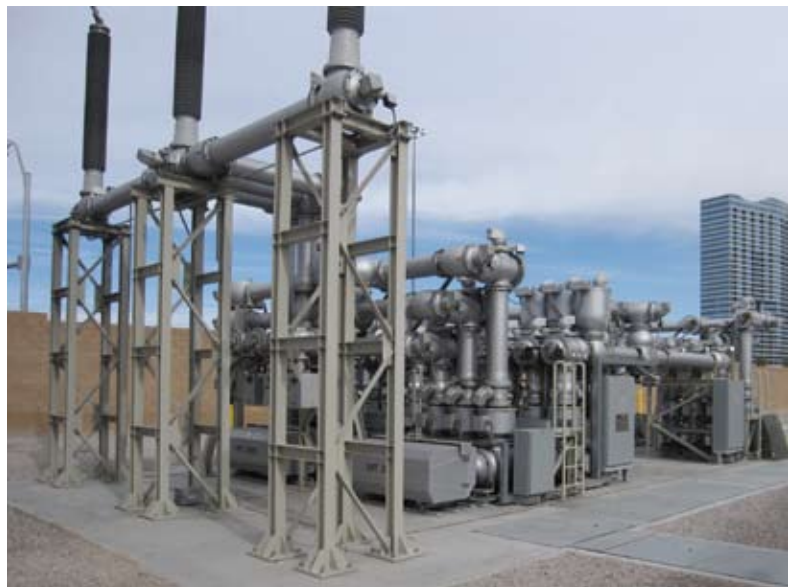
The undamaged 230-kV GIS equipment was protected by the firewalls.

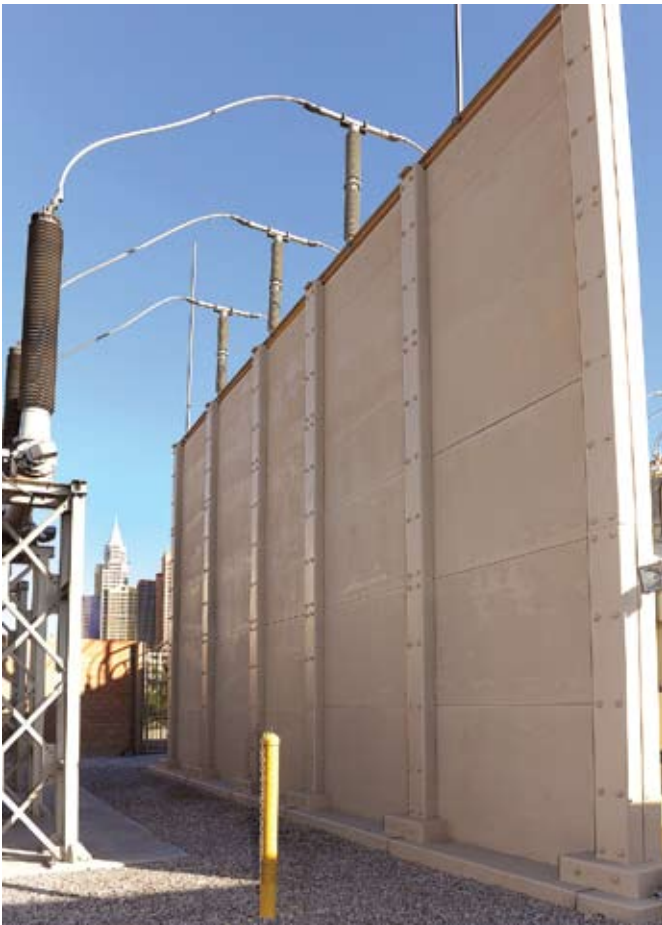
The firewall is restored and none the worse for having lived up to its design function.

The exploding porcelain bushings damaged several of the firewall panels. In fact, one side of the wall was penetrated and, in some cases, the shards became embedded in the firewall panels. Because the panels are fabricated with a hollow space inside, this posed no risk to the structural integrity and they performed as designed.

Fortunately, the majority of the panels were not penetrated, and they were tap-tested to determine their structural integrity. This testing is possible because the Intelli-Firewall is built with hollow "web-core" sandwich panels. A tap hammer — in the hand of an experienced operator — is an effective and simple way to determine the integrity of each panel. This test process, which does not require disassembly, can be done relatively quickly.

In spite of the fierce and prolonged fire on both sides of the autotransformer, only 12 panels had to be replaced. Additionally, several of the vertical beam covers were damaged in the fire and had to be replaced. Again, this was done relatively quickly and did not require any additional maintenance, restoration or replacement of the structural beams.

eration of removing and replacing the damaged panels and bringing the firewalls back into service in only a few days. In short, crews removed the damaged firewall sections and beam covers, replaced them and repainted the protective walls. They removed the burnt transformer. The intense heat from the transformer fire had resulted in the spalling and flaking of the concrete foundation, which had exposed the reinforcing bars in some places. Because of that severe damage, a new foundation was constructed and a replacement transformer was set into place. A spare 230/138-kV autotransformer was on hand, and NV Energy returned the substation to full service in just four months.
